# Minn Kota Service Manual

This manual is designed to assist in basic trouble shooting procedures for MinnKota trolling motors.

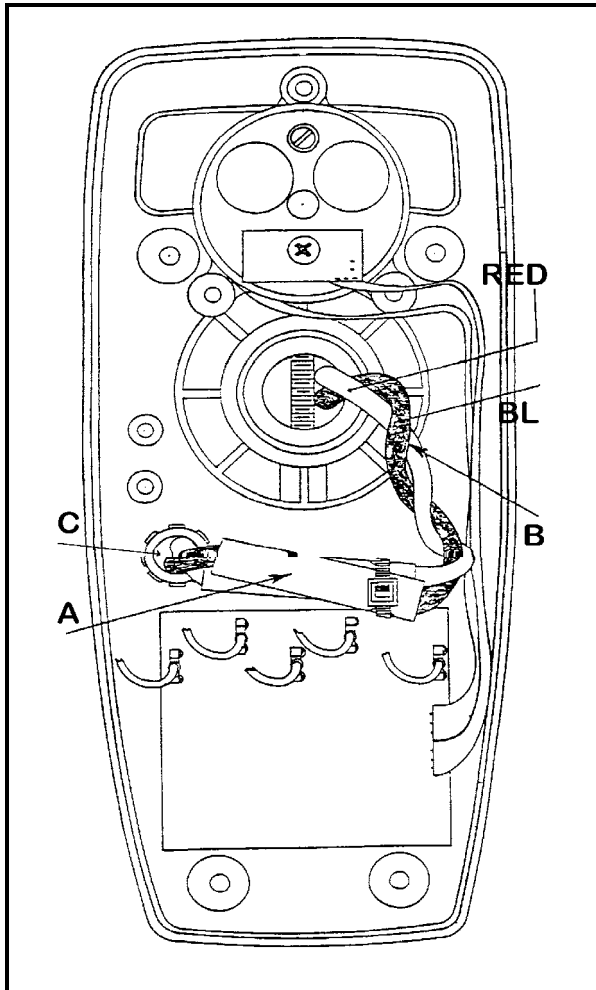
## AutoPilot Calibration

**(PRIOR TO 2001 MODELS ONLY)**

**Step 1.** Place stall clamp on motor.

**Step 2.** Face the control head west.

- F. Using a small non-magnetic blade screwdriver, adjust trim pot #1 so that the voltage displayed on the V.O.M. is as close as possible to 1 volt ( $\pm .25v$ ). (Compass is defective if you cannot reach this tolerance.)

- F. Using a small non-magnetic blade screwdriver, adjust trim pot #2 so that the voltage displayed on the V.O.M. is as close as possible to 1 volt ( $\pm .25v$ ). (Compass is defective if you cannot reach this tolerance.)

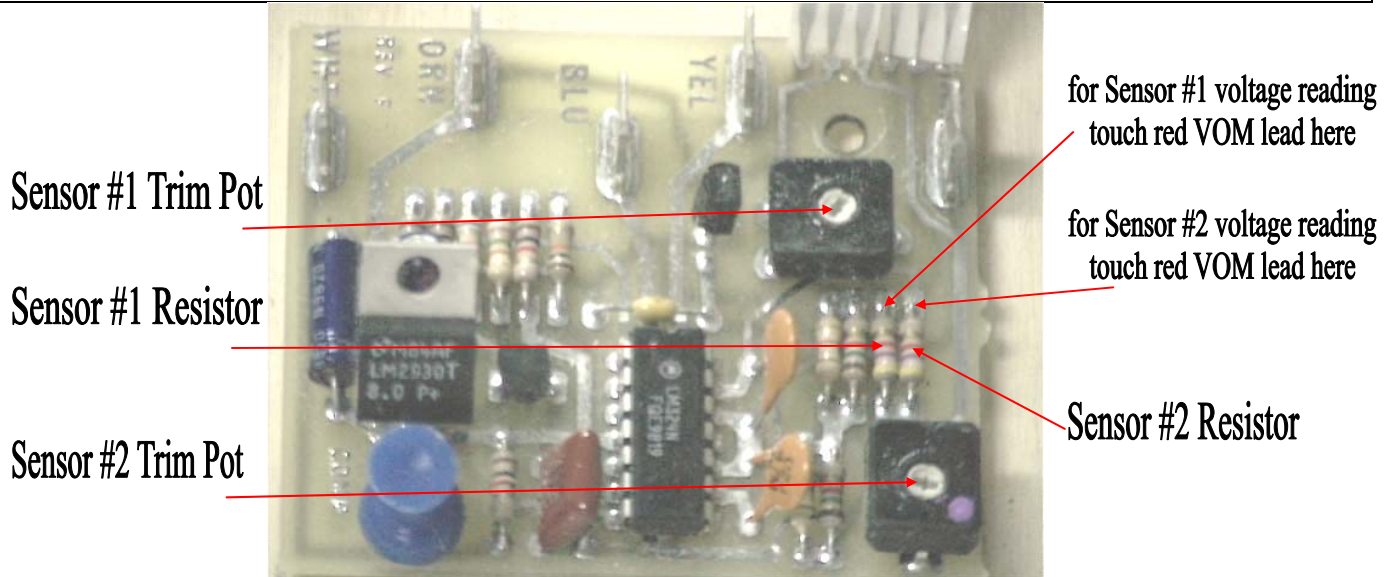
diagram 1

**Note:** You *must* use a non-magnetic screwdriver and a good quality digital V.O.M. in order to properly perform this procedure. Use a V.O.M. with a sharp probe on the red V.O.M. lead, as you will need to pierce through the humiseal coating on the compass control board to obtain accurate voltage readings. In addition, the compass must be in a level position and away from any ferrous metal/steel objects or strong magnetic fields. A small fixture such as the one shown in the accompanying diagrams will allow you to perform these adjustments on your bench top or, if you wish, the compass control board can be left in the motor control box. Be sure to follow the wiring connections as outlined and shown in this procedure.

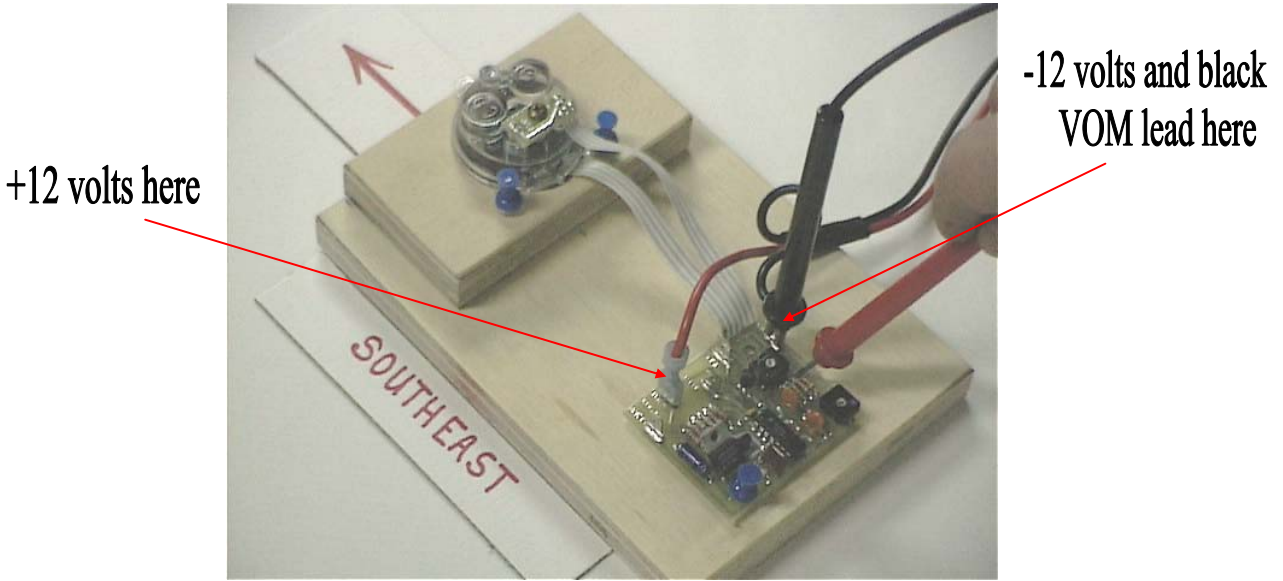
diagram 2

**NOTE: Compass removed from motor and compass card not covered for clarity. Compass card should be covered to block any light on the optical sensors!**

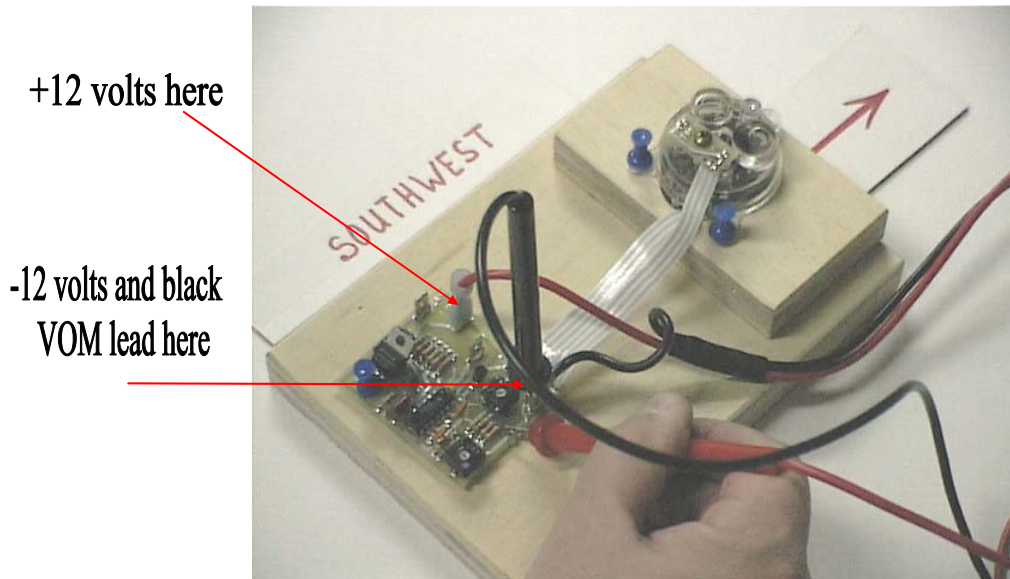
diagram 3

**NOTE: Compass removed from motor and compass card not covered for clarity. Compass card should be covered to block any light on the optical sensors!**

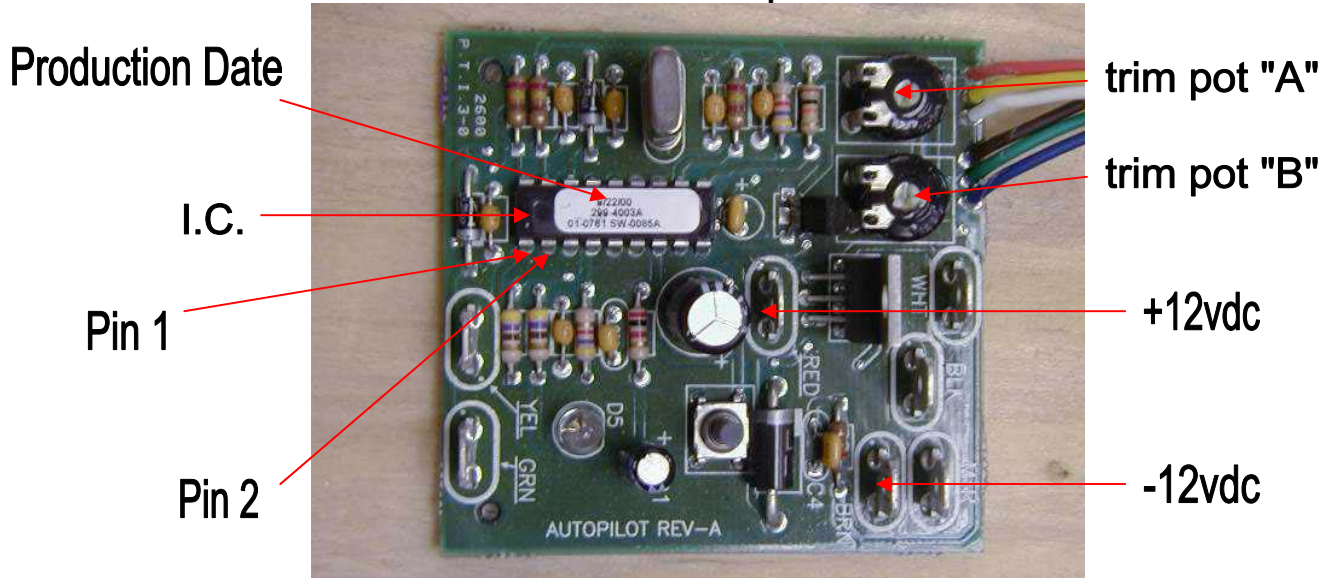
Diagram 1-A

### 2 Variations of compass boards:

(NOTE: The diagrams show this procedure being performed with the compass board assembly removed from the AutoPilot control box for clarity. This procedure can be done without removing compass assembly.)

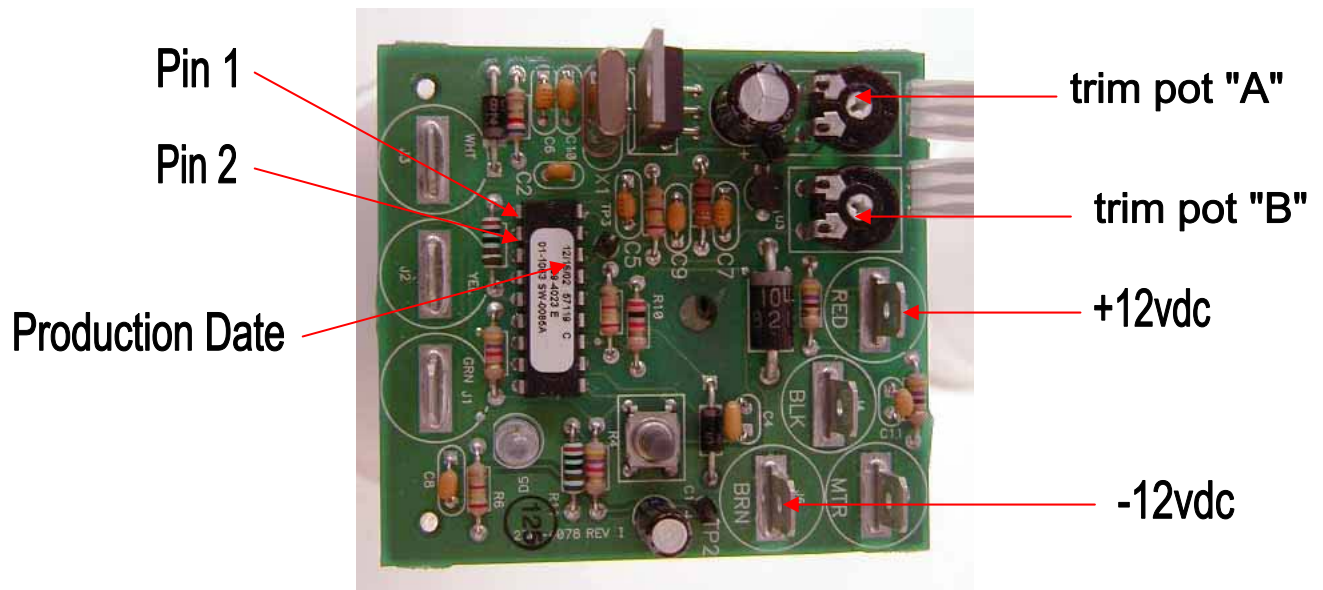
Diagram 1-B

(NOTE: The diagrams show this procedure being performed with the compass board assembly removed from the AutoPilot control box for clarity. This procedure can be done without removing compass assembly.)

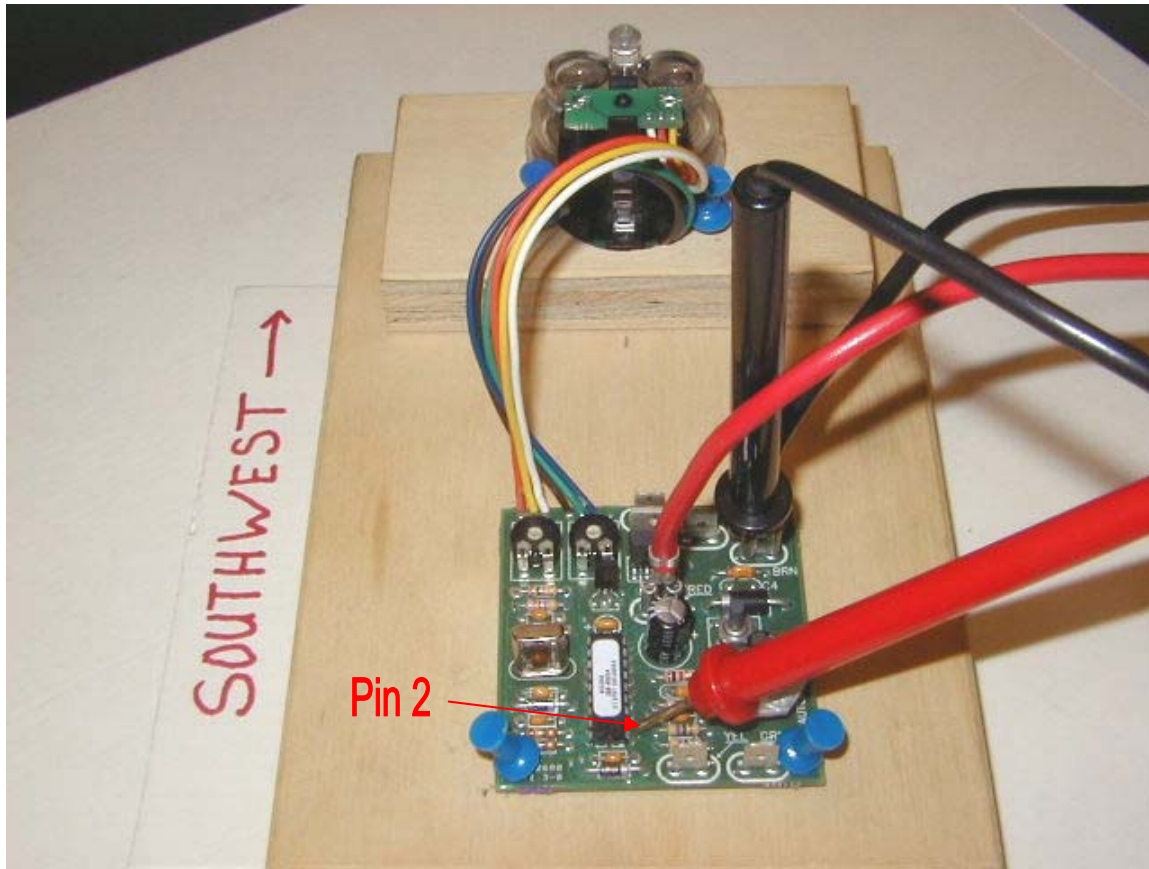
Diagram 3

**On compass boards with date of production after 11/01/00** - using a small non-magnetic blade screwdriver, adjust trim pot "B" so that the voltage displayed on the VOM is as close as possible to 1 volt ( $\pm .25v$ ). (Compass is defective if you cannot reach this tolerance.)

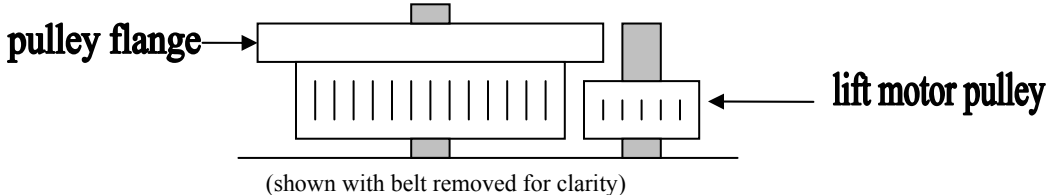
The upgrade kit consists of the parts shown in **figure 7 (page 10-9)**. Many Vantage motors have already been updated in the field with the new *Lift System Upgrade Kit*, so the serial number may not always be a good indicator if the kit is required. To determine if the motor being serviced has the upgrade kit, examine the lift motor pulley. The top of the pulley will be machined away to allow the larger diameter pulley flange to clear.

Please note that many of the lift system parts shown on your Vantage parts list will automatically substitute to this kit. To avoid duplication, simply order P/N 2776517 and you will receive the parts you need to retrofit the new lift system components on earlier Vantage motors. Install the new upgrade kit as per the disassembly and re-assembly procedures outlined later in this section. To insure proper operation of the lift system, install all of the new parts included with the upgrade kit. The kit is shipped assembled for ease of installation. Vantage motors with a serial number **MKAA1501460** or above will have the improved lift system already installed from the factory. Use the upgrade parts list numbers when ordering any lift system parts for later model Vantage motors.

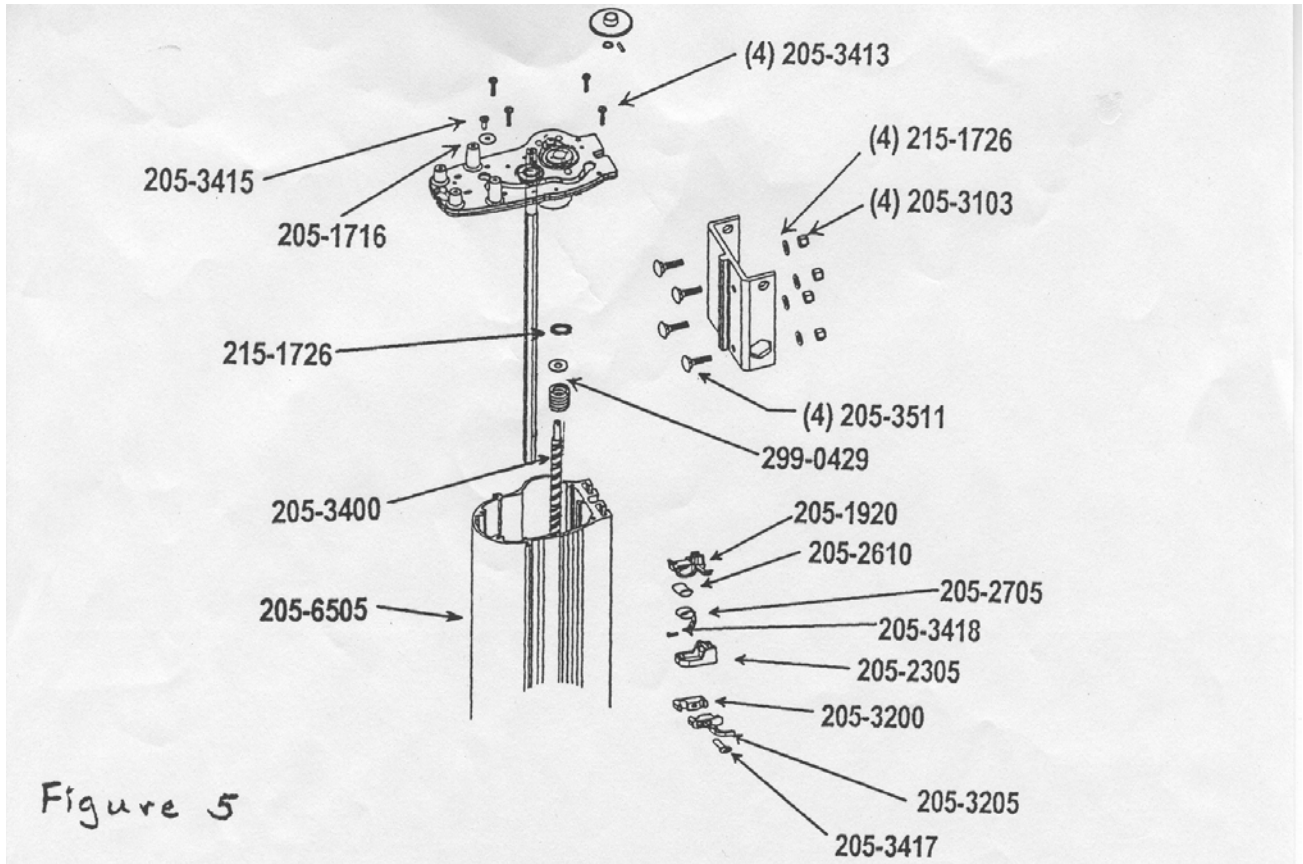
Figure 5

unit. The wire control system consists of two parts, the wire clamp assembly (P/N 2053200, 2053205, & 2053417) and the tape spring assembly (P/N 2051900, 2052305, 2052610, 2052705, & 2053418). (See **figure 5, page 10-8.**) Both of these items are slid onto the raised “rib” located on the inside surface of the housing (P/N 2056505). The lower wire clamp is held in place by means of a small plastic “finger” that catches in a 1/4” diameter hole in the Vantage motor housing (P/N 2056505). (The hole is located on the transom bracket side of the housing 9 inches down from the top.) Use a 1/4” diameter pin punch in this hole. From the outside, push in the end of the finger to release the lower wire clamp and slide it up and lift the tape spring assembly and wire clamp off of the rib. Next, while supporting the Vantage motor lower unit, use the 5/16” nut driver to remove the four screws (P/N 2053414) that hold the lower support cage (P/N 2990420) assembly into the housing (P/N 2056505). After removing these four screws the entire motor lower unit and shaft, lift screw (P/N 2053400), lift screw yoke (2051510), and yoke bearing race (P/N 2056200) can be lowered out the bottom of the Vantage housing. (See **figures 5 & 6, page 10-8.**) Remove the lower wire clamp, wire tie, and tape spring assembly from the motor wire leads. Then remove the two screws (P/N 2053401) that hold the yoke bearing to the motor shaft. Remove the coil spring (P/N 2990429) and washer from the top end of the lift screw shaft. Remove the broken/stripped lift screw yoke from the lift screw shaft. If necessary, turn the lift screw to unscrew the old yoke and bearing race assembly. Slide the old parts up and off the motor wire leads. Install the required new parts and reassemble the Vantage motor in reverse order of disassembly. Take special care not to twist the motor wire leads and to reinstall the wire tie, lower wire clamp, and the tape spring in the same manner and position they were in prior to disassembly.

- a.** Use a 1/8" diameter punch to remove the pin (P/N 2052620) from the lift gear (P/N 2052208) and lift screw shaft (P/N 2053400).
    - b.** Remove the lift gear from the lift screw shaft. (**See figure 5, page 10-8.**)

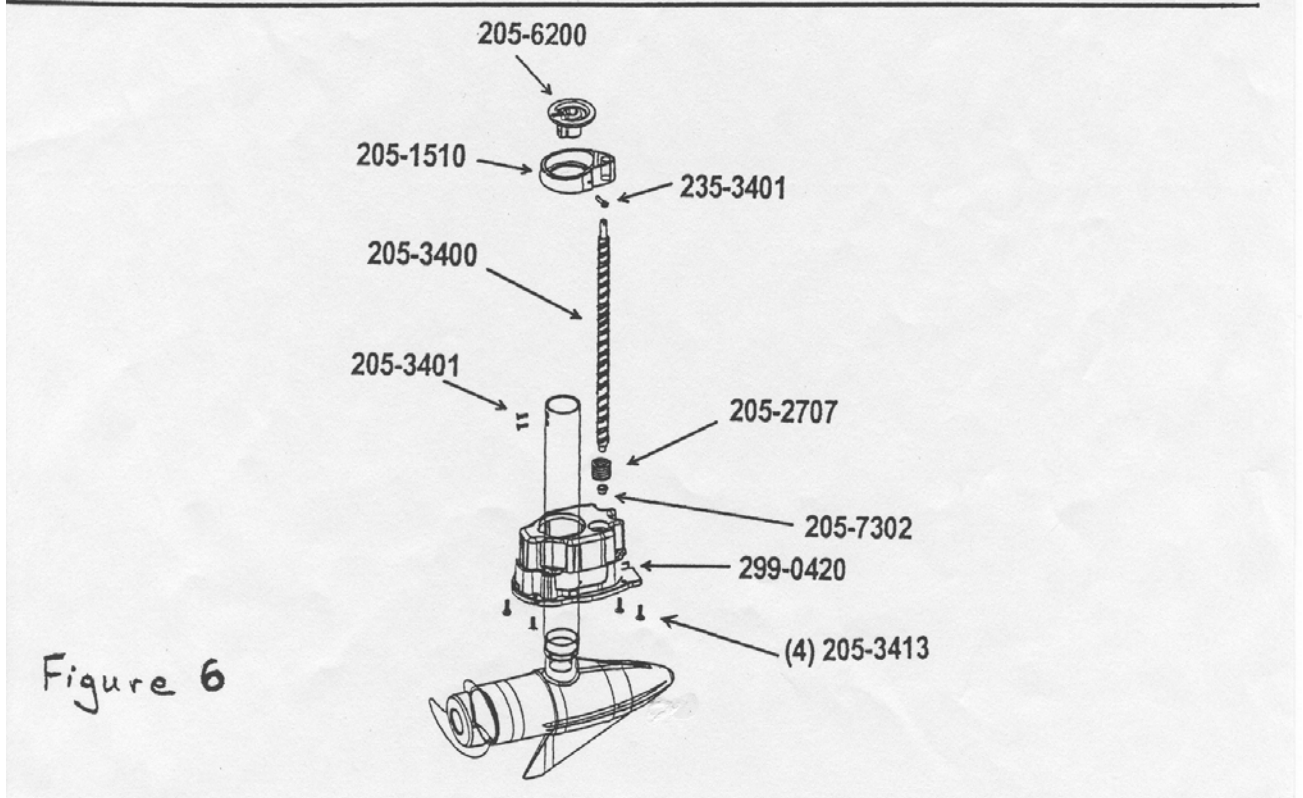
Figure 6

- D.** If it was determined in **Case II Step 3B-2** that the lift yoke (P/N 2051510) (**see figure 6, page 10-8**) is broken or stripped further disassembly is required. **NOTE:** the Vantage motor uses a retractable tape spring to hold/control the two-conductor wire that goes to the motor lower

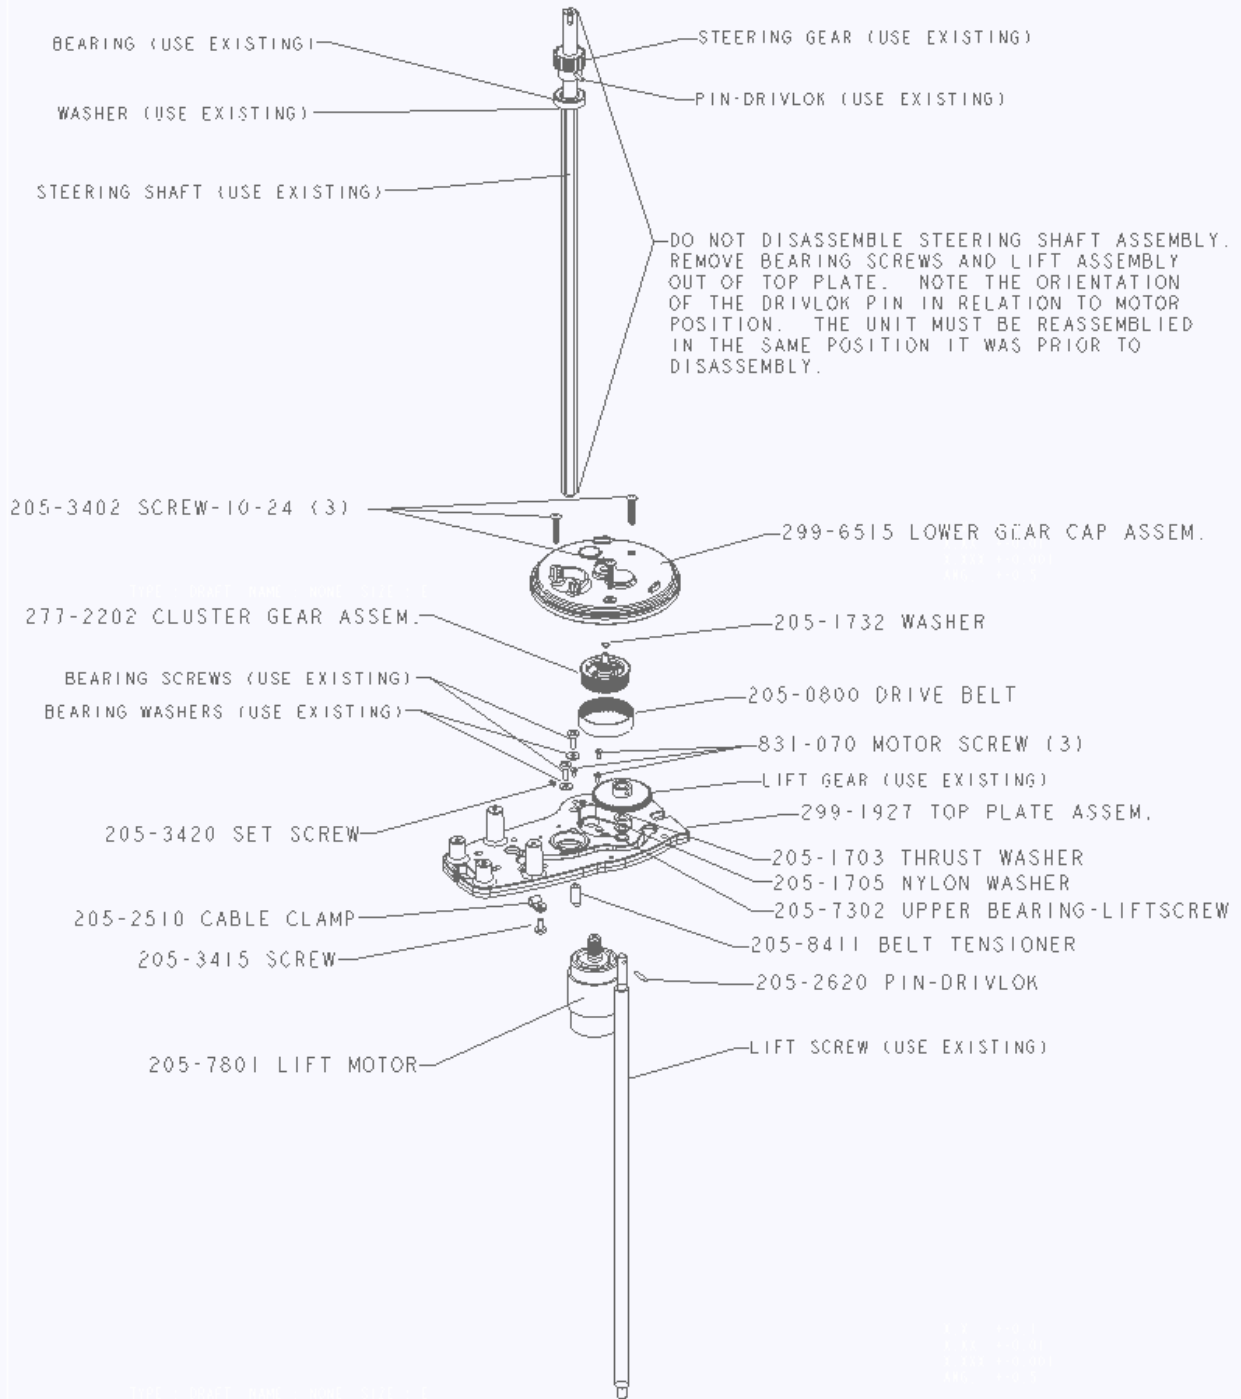
Figure 7

277-6517 VANTAGE UPGRADE KIT

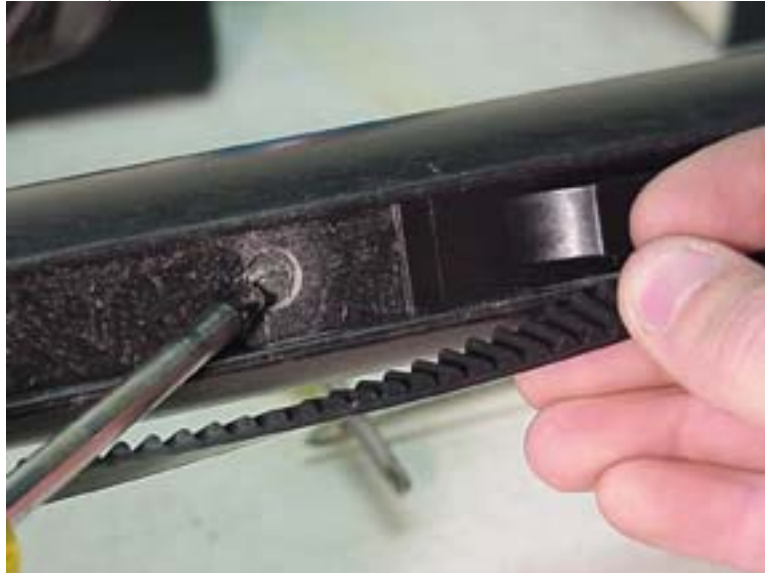
- B-2.** Replace anti-rattle bushing if detent catch on bushing is damaged/broken.
    - B-3.** Put anti-rattle bushing back in its proper place making sure that the detent catch is secure in the hole provided in the outer shaft lift belt channel. (see below)  
(On 45” shaft models, the cam profile will extend over the hole in the tube when motor is fully assembled.)

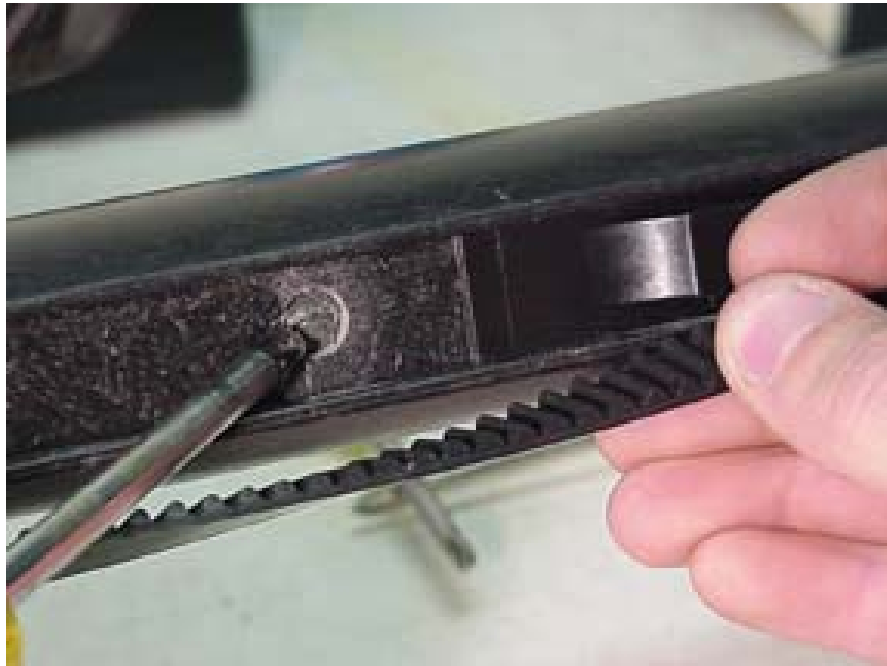
- Step 1.** Check to make certain that the anti-rattle bushing is in its proper place. (see below)  
(On 45" shaft models, the cam profile will extend over the hole in the tube when motor is fully assembled.)

- A.** The anti-rattle bushing catch must be in the hole provided in the lift belt channel. If it is pushed out of position during reassembly after transducer routing, the Genesis motor will not steer or will steer with great difficulty.
- A-1.** Disassemble the motor per the transducer routing procedure to correctly position the anti-rattle bushing back in its proper place.
- A-2.** Reassemble the Genesis motor and test all functions for proper operation.
- Step 2.** Visually inspect the primary gear retaining screws for proper installation and tightness (*see Steering System Module Case I, Step 1 on page 11-3*).
- Step 3.** Correct cause of steering problem, reassemble, and test unit for proper function.

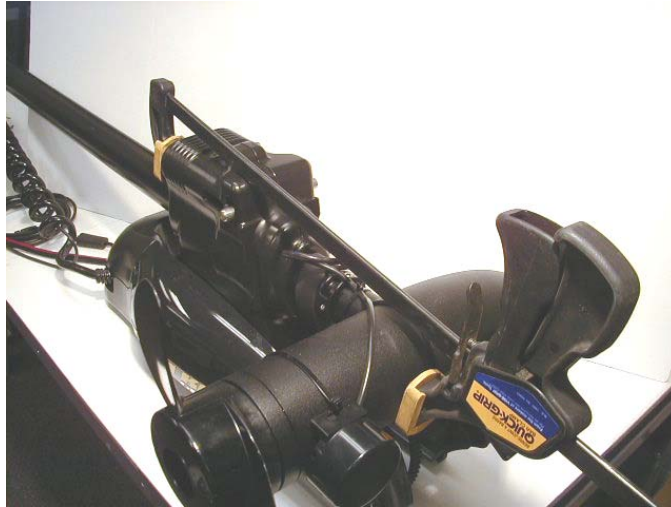
**Step 1.** With motor in fully stowed position, place “Quick Grip” clamp on lower unit and lift housing. (see figure below)

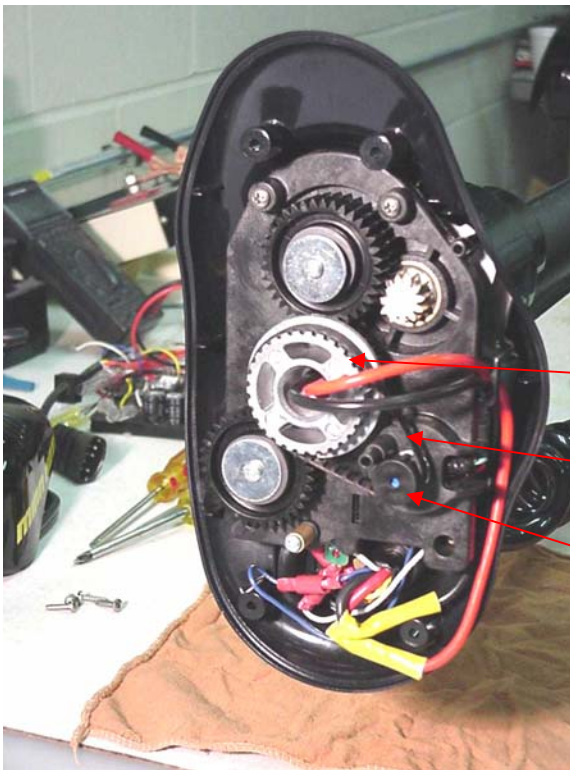
**Primary Gear**

**Step 2.** Remove the control box cover screws and cover assembly to expose the Genesis steering system. (see below)

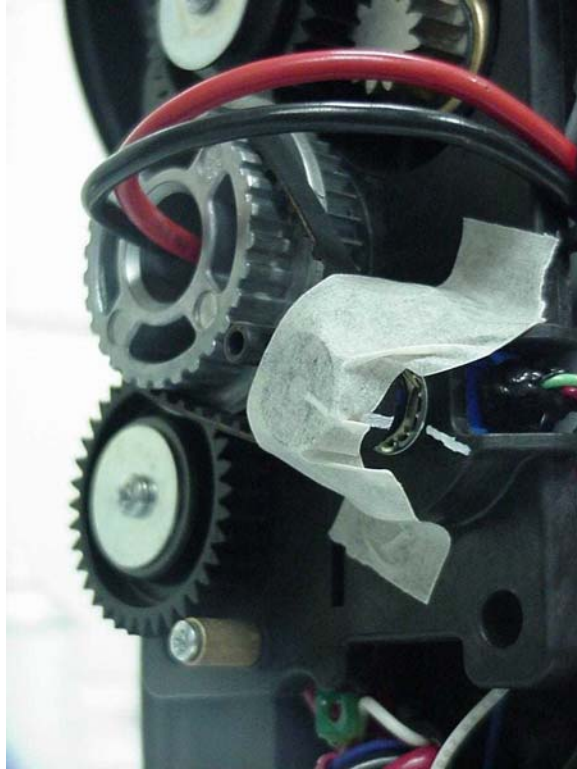
- A. Mark and tape the steering potentiometer (as shown below).

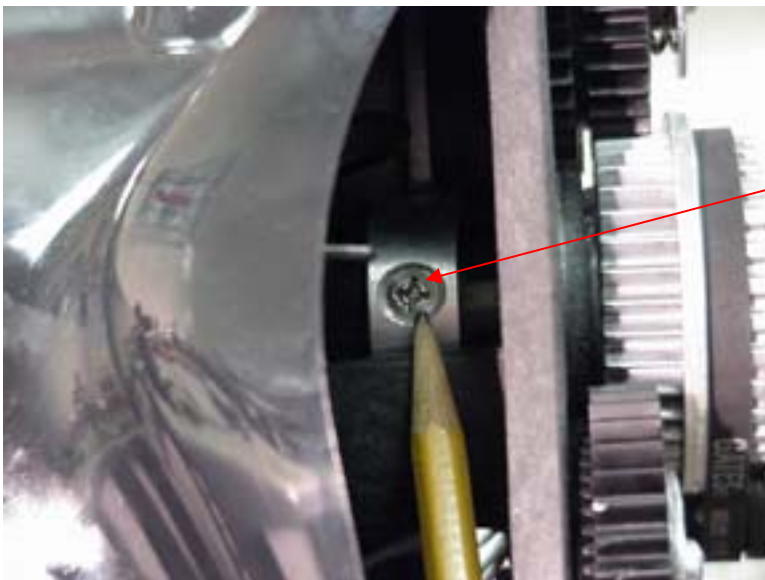
**Primary Gear Retaining Screw**

- B. Disconnect the red and black motor leads and slip steering potentiometer belt up and off of the primary gear. (Take care not to rotate the steering potentiometer).
- C. Remove the two Phillips Flathead countersunk screws that hold the primary gear assembly in the inner shaft. **Note:** Heat will be required to remove these screws, as they are held in place with **Loctite**.

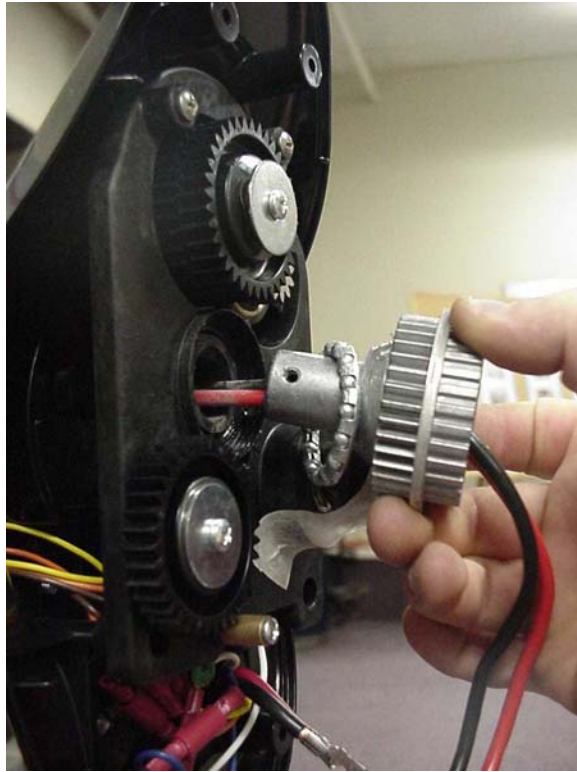
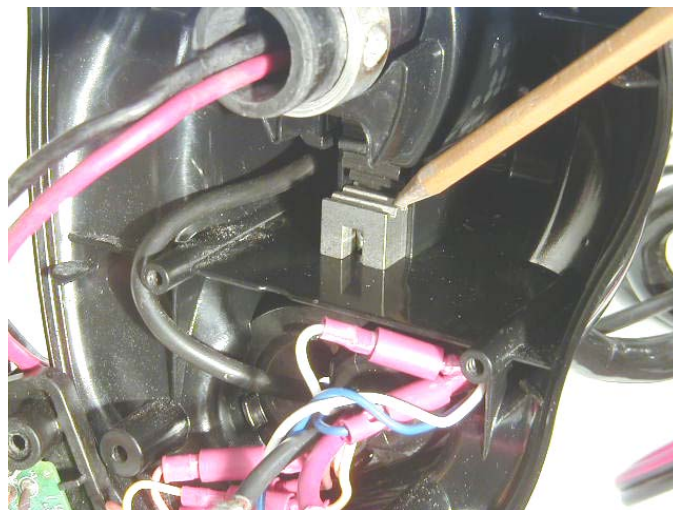
**Step 3.** Remove the primary gear and top bearing from the steering chassis. Then remove the four screws that attach the steering chassis to the control box. This will enable you to access the lift belt tensioner. (see figures below)

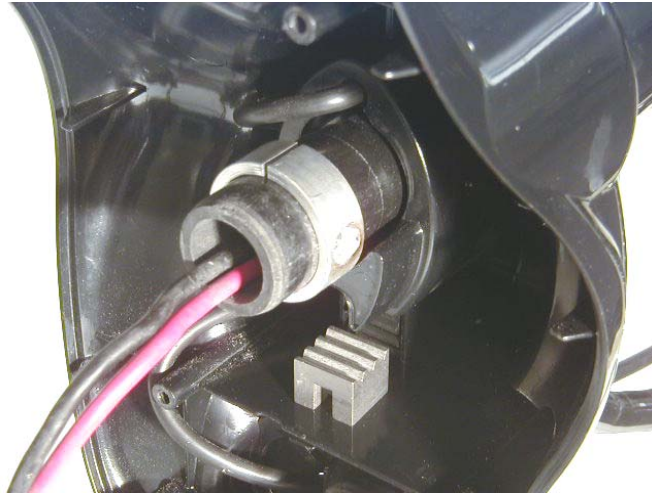
- A. Unscrew lift belt tension screw all the way while observing the lift belt tensioner. Note how the tensioner engages the teeth on the upper end of the lift belt. (see below)

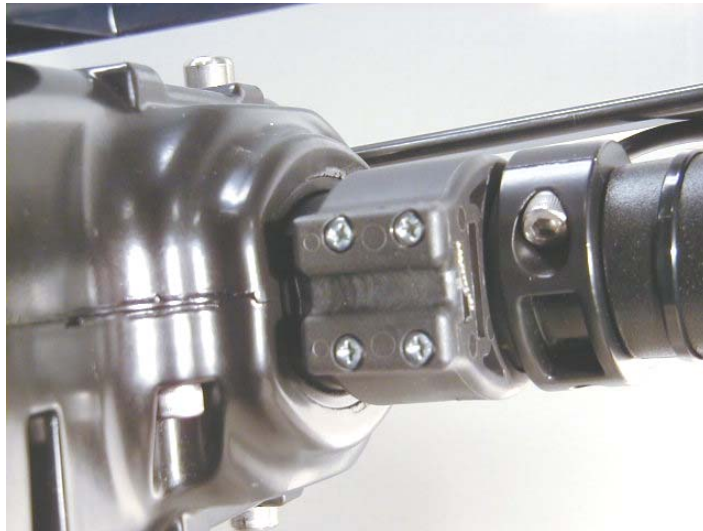
- Step 4.** Remove the four screws that attach the lower end of the lift belt to the outer shaft lower collar. (see below)

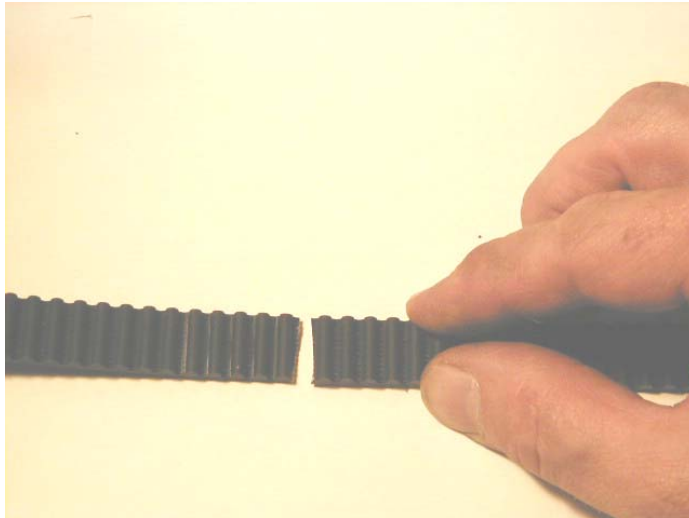
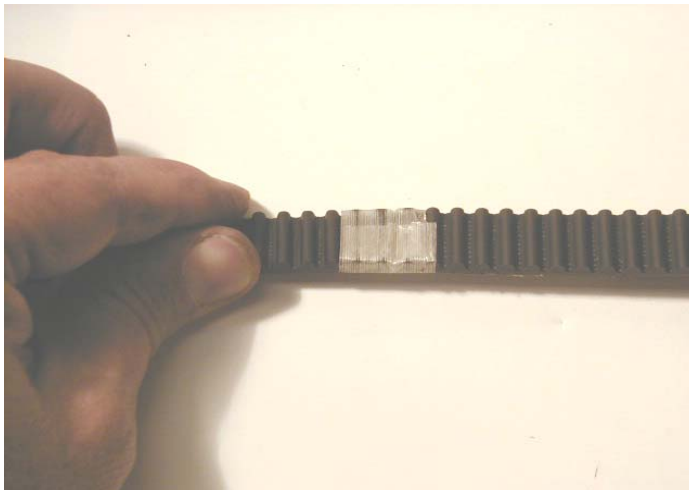
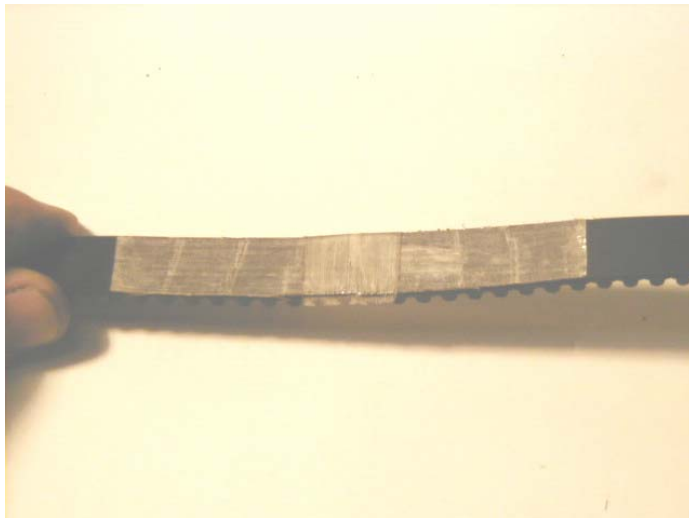
- A. Butt the ends of the new and old lift belt together, add a drop of super glue, and securely tape them to each other (as shown in the 3 figures below). Note: Be sure that the length of the new lift belt matches the shaft length of the motor being serviced.

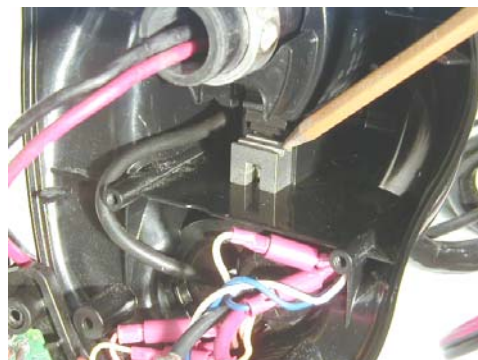
- A. Unscrew the lift belt tension screw (item #17 of the Steering Module parts explosion) while observing the lift belt tensioner. (see figure below) Note how the lift belt is routed and attached to the tensioner for later reassembly.

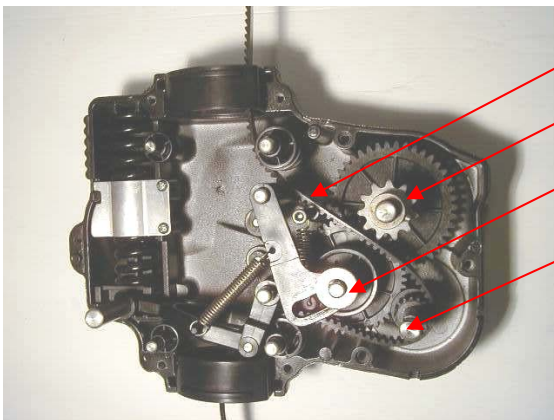
**Lift Belt**

- A. Remove the eight ¼ x 20 socket head capscrews (item #50 of the Lift Housing parts explosion) that hold the left and right halves of the lift housing together.
- B. With the eight screws removed, use a blade screwdriver to carefully pry apart the lift housing halves. Lift the left half up and off the right half to expose the internal workings of the lift housing. (see figure below)

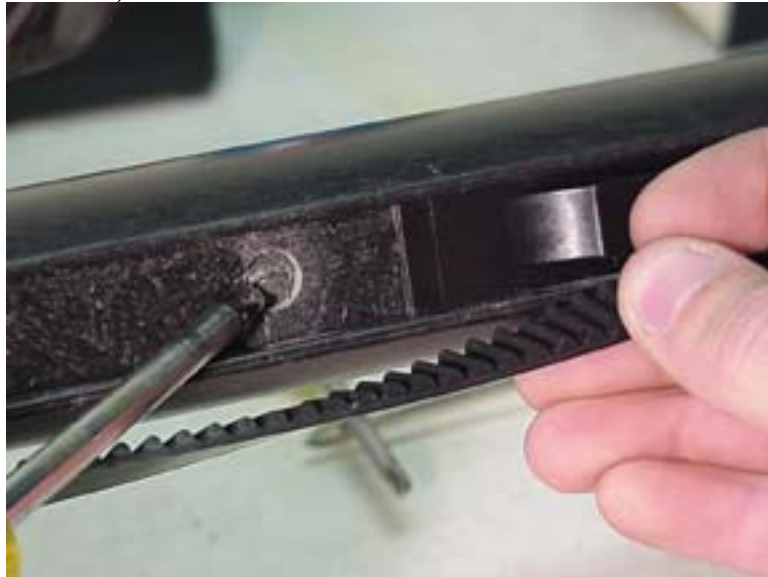
- B-1.** Visually confirm this by checking for the anti-rattle bushing detent catch in the hole provided in the belt channel of the outer shaft. (see below)

**(On 45" shaft models, the cam profile will extend over the hole in the tube when motor is fully assembled.)**

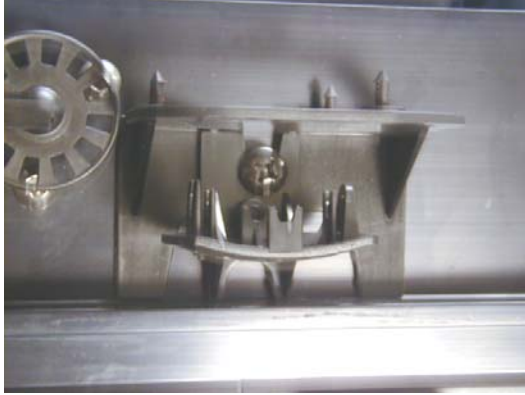
- C. When replacing the main control board on a Genesis *AutoPilot* motor, install the compensating magnet bracket and magnet rods (P/N 2881937) which is included with the new AutoPilot control board assembly (early units did not utilize compensating magnets). See figure below. (*If you order the older control board by the old P/N 2224011 for 12-volt units or P/N 2224013 for 24-volt units, it will sub to a kit that has everything needed. If you order the control board by the current part numbers, P/N 2224014 for 12-volt units or P/N 2224016 for 24-volt units, you will not receive the compensating magnet bracket and magnet rods*).

- C-1.** To install the compensating magnet bracket remove the compass bracket screw, (item #32 on the Base/Housing parts explosion) and position the compensating magnet bracket in place below the AutoPilot compass-mounting bracket. Reinstall the bracket screw to hold both the compass bracket and the compensating magnet bracket in place. **Do not install the 2 magnet rods at this time!**
- D.** Install the compass assembly on the compass bracket (re-use the orange grommets from the old compass).
- E.** Install the encoder (writing on the encoder to face up) and LCD in their places. Reinstall the center display housing/LCD and *right* sideplate.
- F.** Proceed to the “**Initial Board Programming Procedure**” (*page 11-27*).

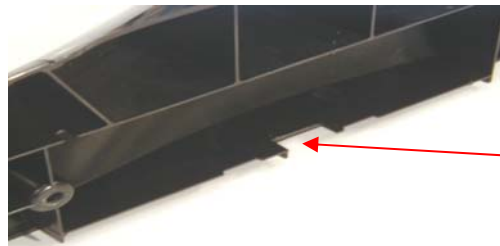
notch out here

- Step 1. Calibrating Compass Software** (Note: steering functions will be inactivated during this step)  
Using the Genesis Test Pedal, P/N 2772040T, press and hold down the TrimUp, TrimDown, and the right momentary steering switches while turning the Master Switch ON.
- A. Release TrimUp, TrimDown, and right momentary switches.
  - B. LCD should only display the **AutoPilot** icon. (If the icon is flashing, the motor is trimmed up too high and will not allow the AutoPilot feature to operate. Use TrimDown switch to lower motor, then reactivate the AutoPilot feature by pressing the mode switch once.)
  - C. Temporarily place the left sideplate in position to cover the compass unit and to block UV light that could affect the compass sensors. Note: earlier sideplates must be notched out as shown in the diagram below to clear the compass magnet bracket.

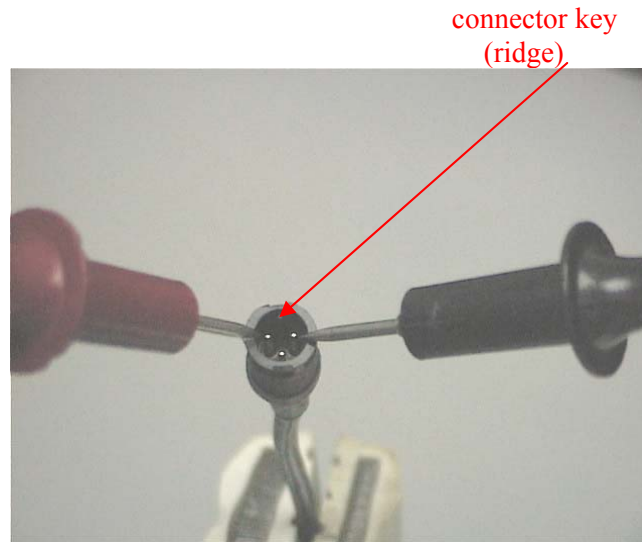
Figure 1

- A. Measure the capacitance of the transducer at the extension cable plug end that exits the motor coil cord (PD/AP and Genesis models) or footpedal (Maxxum foot-control models) using your capacitance meter as per **Figure 1**. Touch the red and black probes from your capacitance meter to the correct pins on the plug (transducer + and -). For proper orientation, be sure the connector key (ridge) is at the top of the plug as in **Figure 1, page 12-3** (just above and between the red and black probes).

**Step 2.** Verify capacitance measures according to the following picture (**Figure 1, page 12-3**) and chart (**Chart A, page 12-3**).

- A. Retest per **Step 2**.

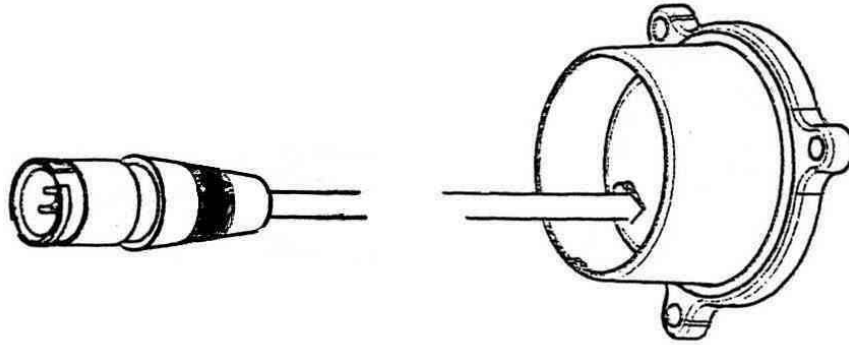
CONNECTOR  
PIN-OUT DETAIL

**Note: Take transducer capacitance readings across the TX(-) and TX(+) pins.**

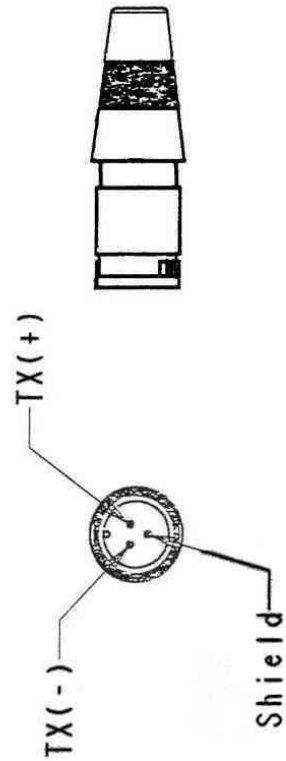
CONNECTOR-END VIEW

MINN KOTA Part #	Capacitance Maximum	Capacitance Minimum
987-005	1006.23 pF	623.53 pF
987-004	968.50 pF	596.66 pF
987-003	945.87 pF	578.14 pF

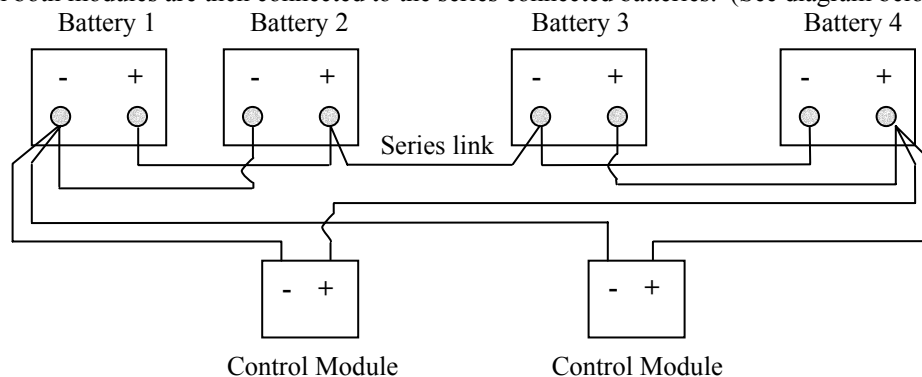
**Step 2.** If using four 12vdc batteries to power twin EM or EP models, check to make sure that both modules are connected to the same power source. For proper operation, batteries 1 & 2 should be connected in parallel, next connect batteries 3 & 4 in parallel. Then series connect the two banks of paralleled batteries. The battery leads from both modules are then connected to the series connected batteries. (See diagram below.)

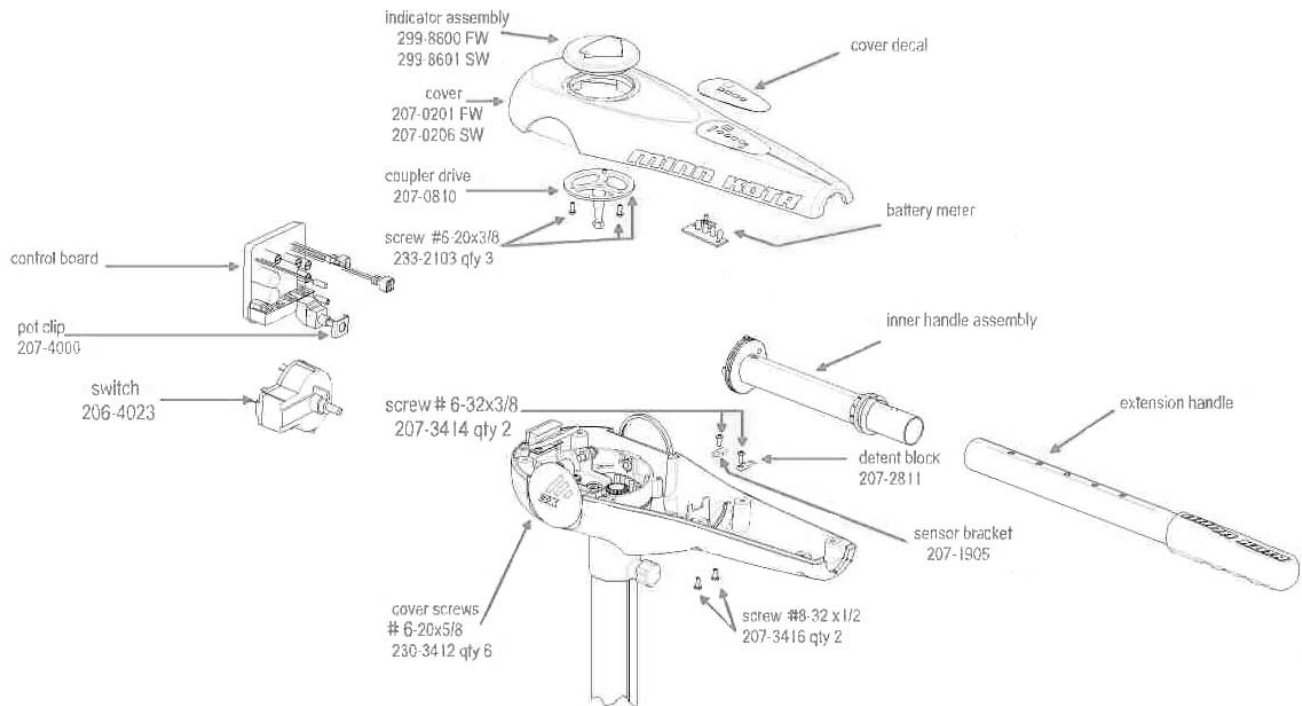
Fig. 3

- A-1.** On 5-speed 3X models, the switch can easily be separated from the control box when the wires are disconnected.
- A-2.** On variable-speed 3X models, loosen the Phillips pan head screw (P/N 2073414, #6-32 x 3/8”) holding the P/N 2071905 sensor bracket in place. (Sensor bracket is located in control box along side the potentiometer support.) Loosening the screw allows removal of the magnetic on/off reed switch attached to wires exiting the control box. (On/off reed switch is the small 5/8” long, 3/16” diameter black cylinder with 2 small black wires attached.) Then remove the two P/N 2073416, #8-32 x 1/2” socket head cap screws (located in recessed openings on the underside of the control box) using a 9/64” allen wrench/driver. The control board is then free to be removed. (see Fig. 3)

**Step 10.** Re-install the control board or 5-speed switch using the fasteners or parts removed during disassembly. (see Fig. 3, page 17-2)
