# Minn Kota Service Manual

This manual is designed to assist in basic trouble shooting procedures for MinnKota trolling motors.

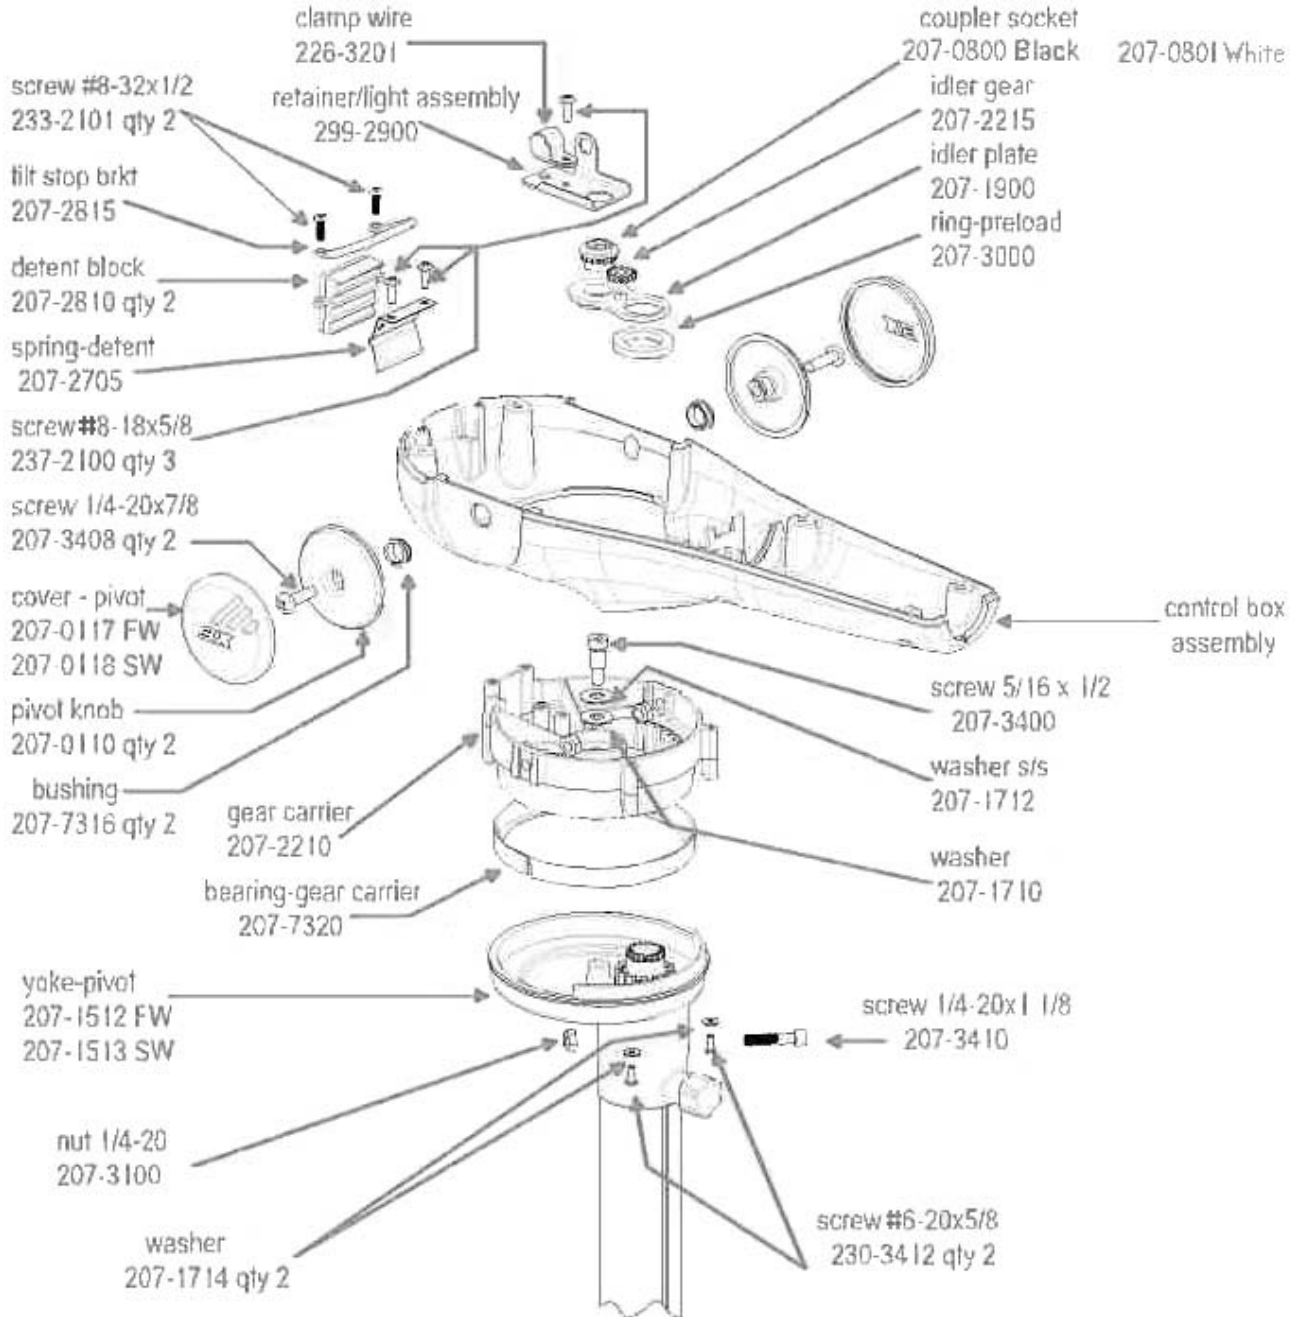
Fig. 4

- B. **IMPORTANT** – With the control box parallel to the motor lower unit, note how two sides of the hexagon ID of the coupler socket (P/N 2070800 black coupler socket for bow mount motors, P/N 2070801 white couple socket for transom mount motors) are parallel to / in-line with the control box pivot screws (P/N 2073408). When reassembling a 3X motor, the coupler socket (which drives the directional indicator) must be repositioned in this exact same manner for proper orientation of the directional indicator arrow. (Directional arrow is parallel to the motor lower unit pointing towards the direction of boat travel when in the water with the motor running.)
- C. After removing the retainer / light assembly, remove the coupler socket, idler gear, idler plate, and preload ring (P/Ns 2070800/2070801, 2072215, 2071900, and 2073000). (see Fig. 4)

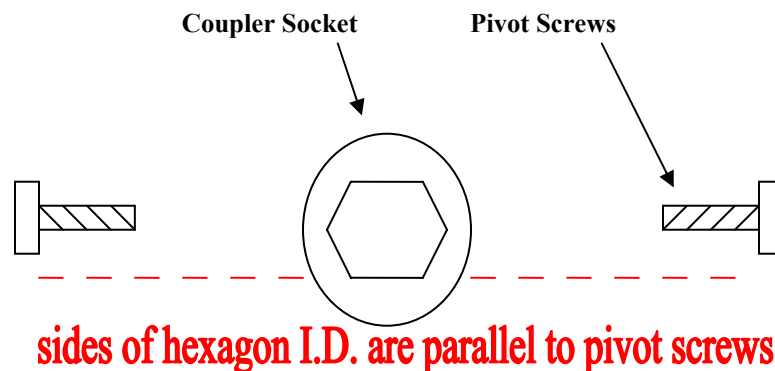
**Step 9.** Re-install the preload ring (P/N 2073000), idler plate (P/N 2071900) idler gear (P/N 2072215), and coupler socket (P/N 2070800 or P/N 2070801). (White coupler socket for transom mount motors and black coupler socket for bow mount motors.)

- A. As noted during disassembly, position the coupler socket so that any two parallel sides of the hexagon I.D. of the coupler socket are as close as possible to being parallel to the control box pivot screws.

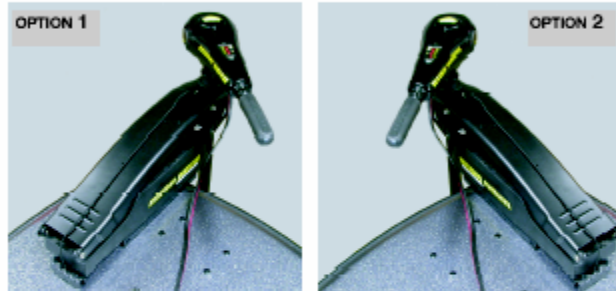
THE DEPTH COLLAR COMES SET FOR STANDARD CONFIGURATION OR OPTION #1

- 1). Remove the depth collar from bag and review your type of mounting.

- 2). Set the depth collar aside until the motor is mounted and aligned.

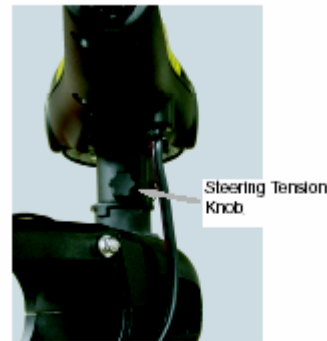
- 5). Align handle parallel with the centerline of the boat. Hold the handle and rotate the outer shaft until the steering tension knob is aligned with the handle. See pictures below. (Handle and knob are aligned)

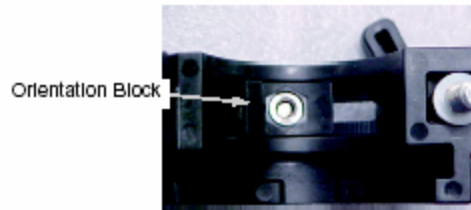
7). If mounting configuration or option #2 is preferred, the orientation block must be rotated 180°. The orientation block must be removed and rotated so the retaining key is on the right hand side of the screw. The picture below shows orientation block configuration or option #1.

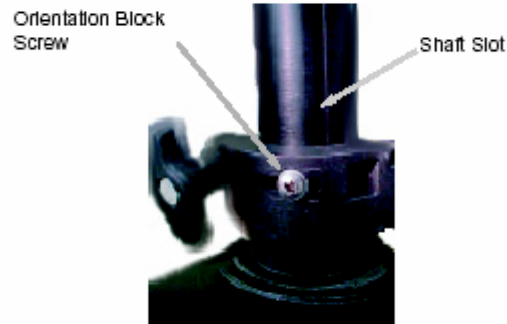
10). Loosen orientation block screw so key can freely slide. Push on the screw and slide the orientation block until key falls into the slot in shaft.
